UNITED STATES ENVIRONMENTAL PROTECTION AGENCY

Site:	Maline Creek
ID #	MOD980631162
Event:	1.6
Other:	2-22-93

SUBJECT: CertainTeed Transite Plant, St. Louis, Missouri,  
Site Asbestos Evaluation, 1/28/93 (SBR31)

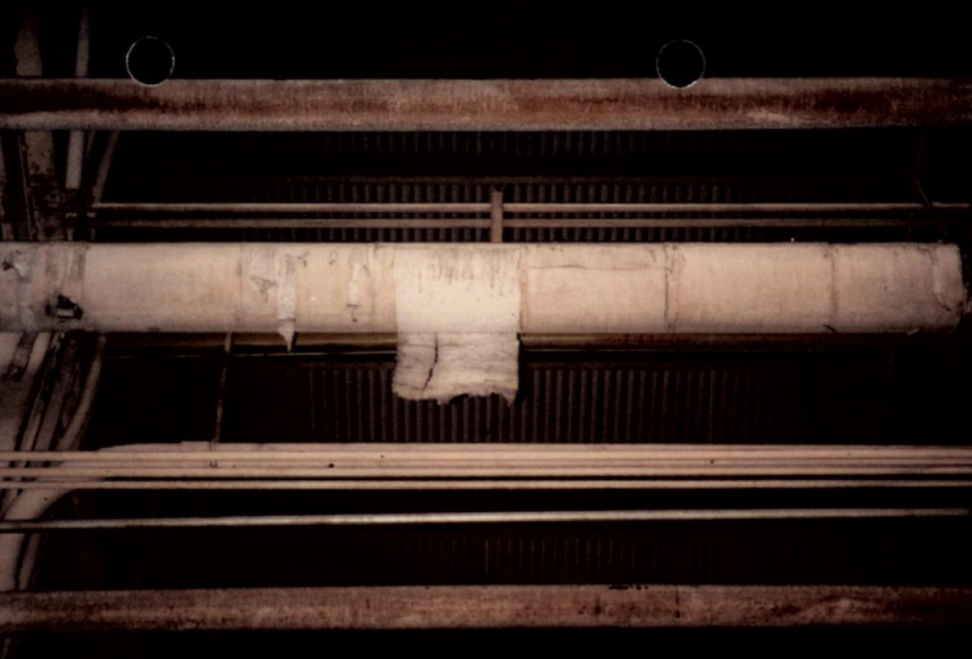
Photo #1

CAPTION: Southwest building.

10" diameter pipe, covered with block-type insulation. Suspended from ceiling. Some damaged wrap.

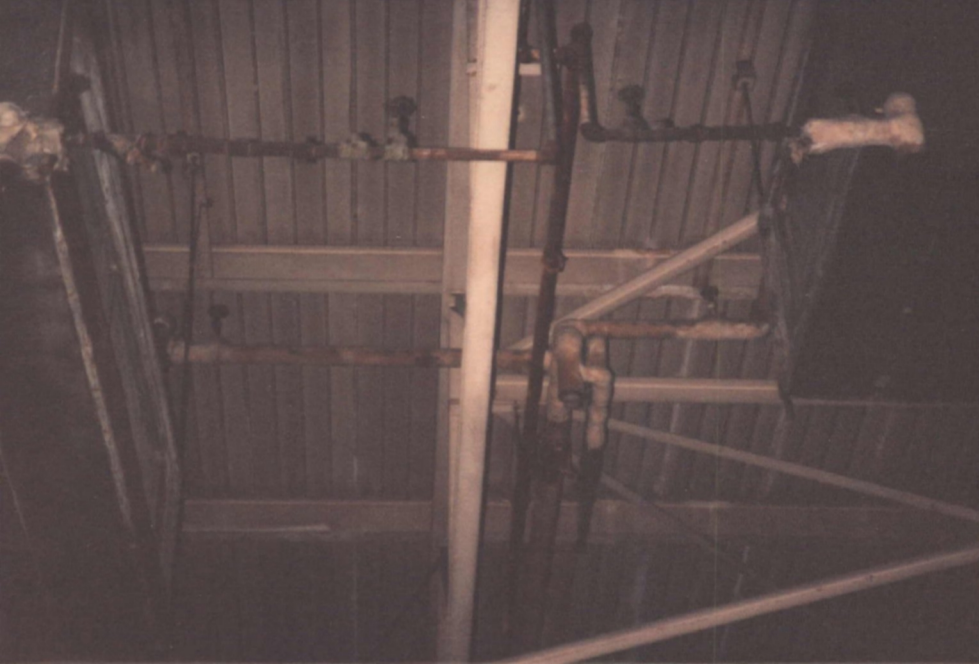
Photo #2

CAPTION: Southwest building.

Ceiling heaters and connecting pipes. Some  
insulation missing.

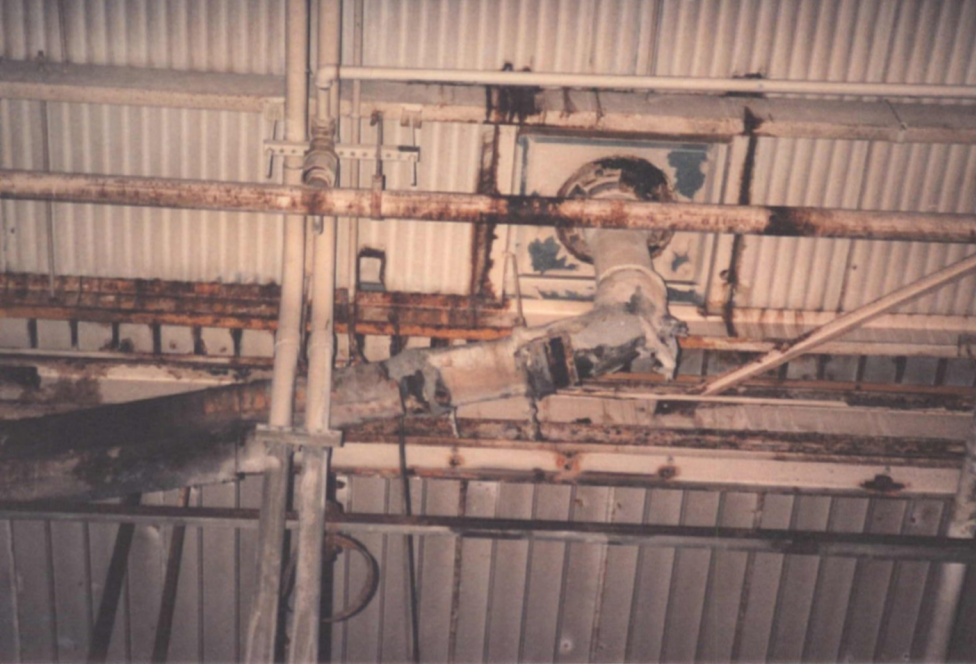
Photo #3

CAPTION: Southwest building.  
Insulated roof drain pipe with damaged  
insulation.

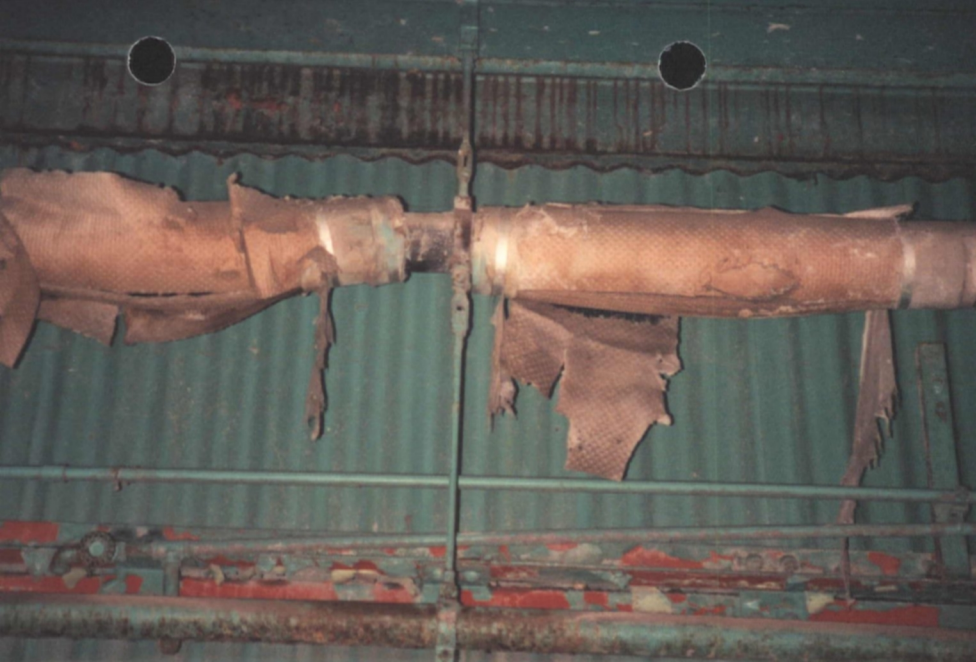
Photo #4

CAPTION: Southwest building.

Pipe with deteriorating paper wrap.

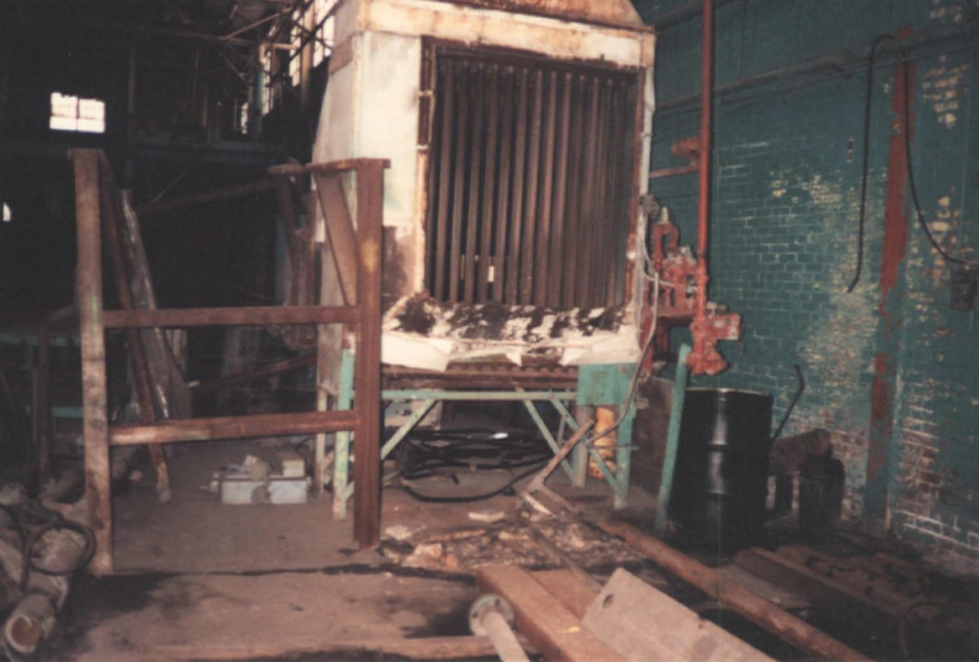
Photo #5

CAPTION: Southwest building.

Sample Site SBR19-001.

Equipment covered with block-type insulation.

Some of the insulation has fallen onto floor.

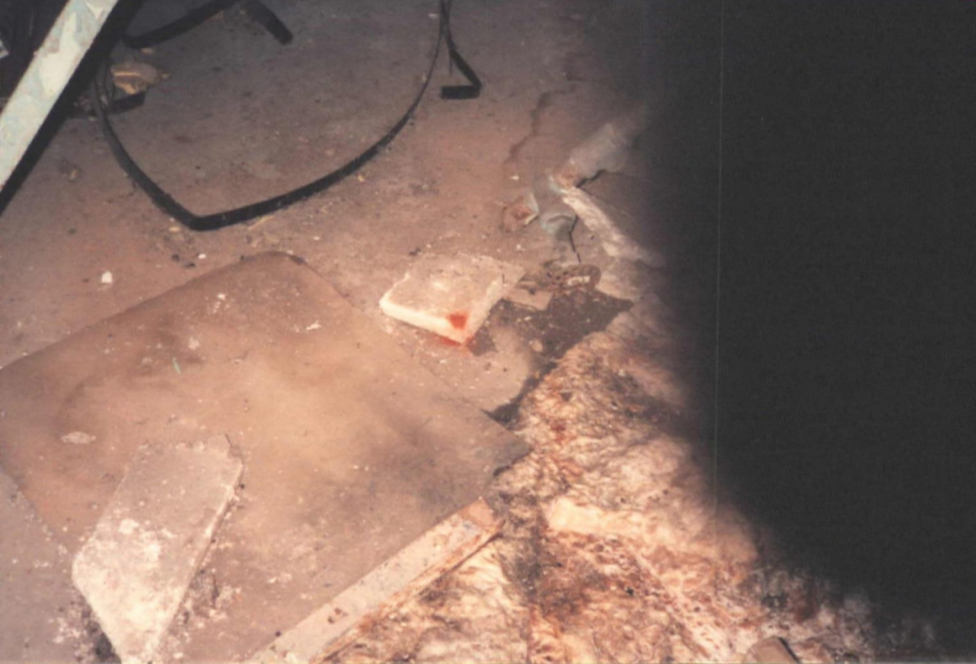
Photo #6

CAPTION: Southwest building.

Sample Site SBR19-001 obtained from piece of  
block-type insulation located underneath  
equipment.

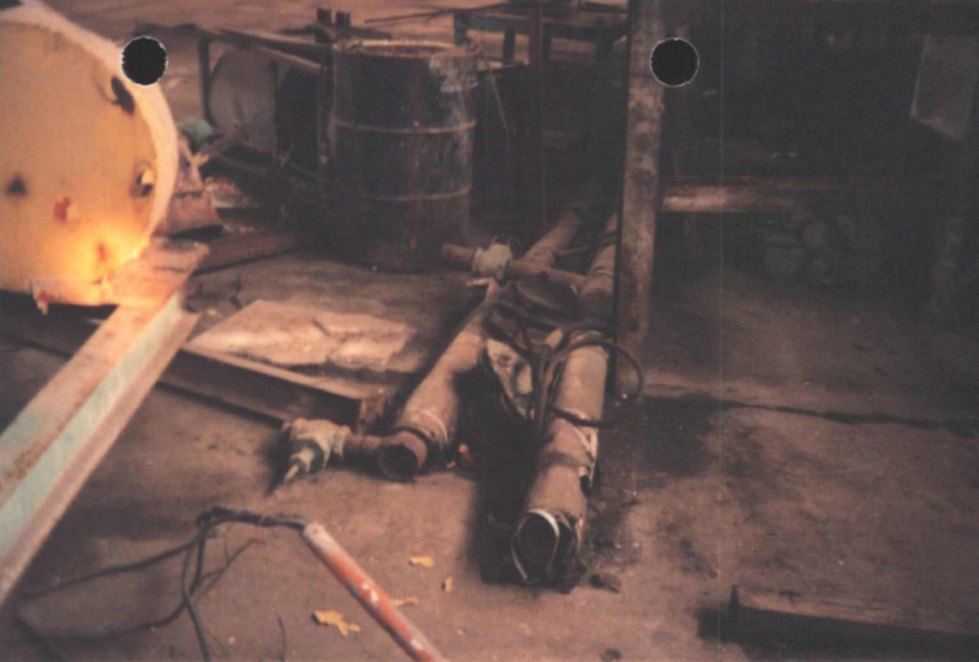
Photo #7

CAPTION: Southwest building.

Cutoff pipes laying on the floor.

Sample Site SBR19-002 obtained from pipe on right. Pipe covered with a heavy woven cloth material.

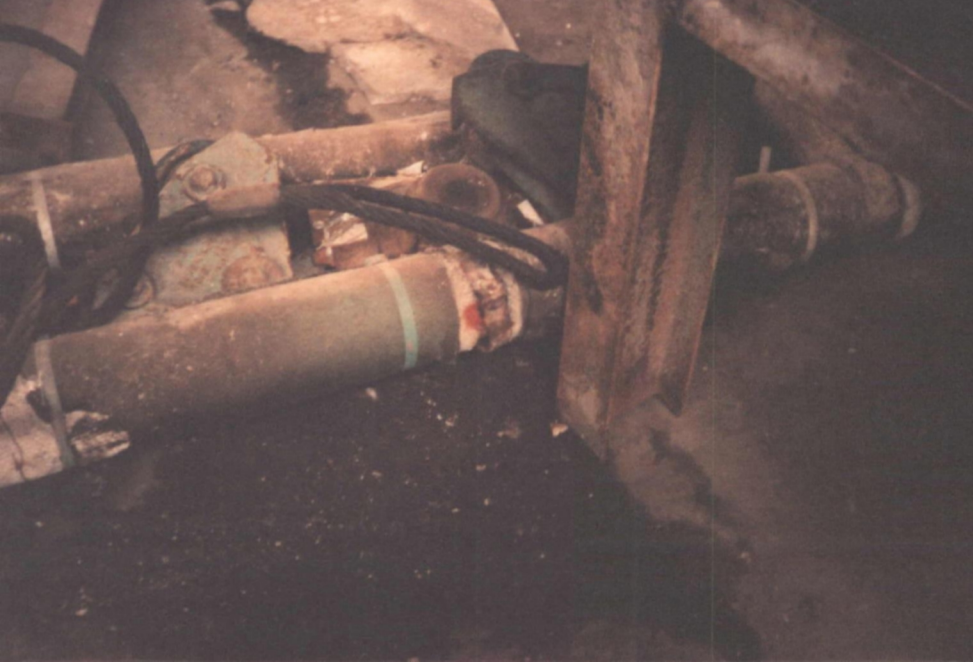
Photo #8

CAPTION: Southwest building.

Sample Site SBR19-002.

Heavy woven cloth pipe insulation.

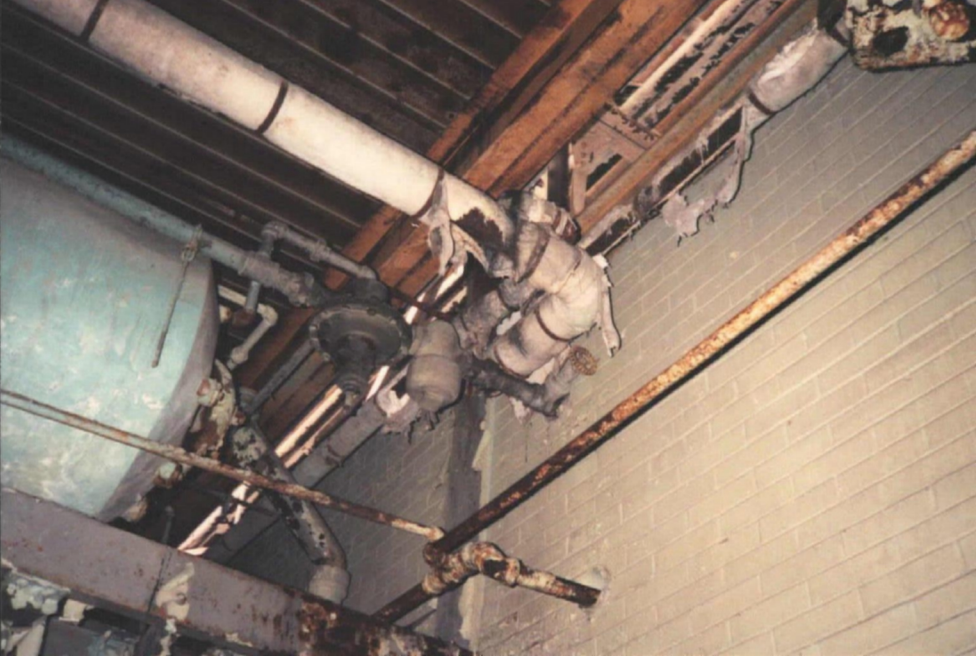
Photo #9

CAPTION: Southwest building.  
Deteriorating pipe insulation in bathroom.

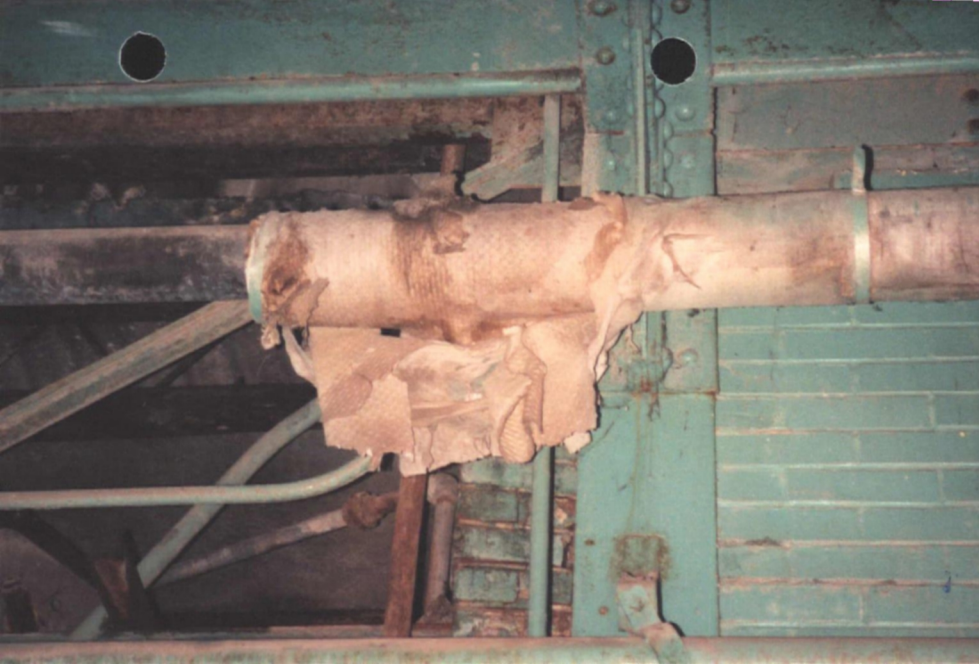
Photo #10

CAPTION: Southwest building.

Deteriorating paper-type pipe insulation.

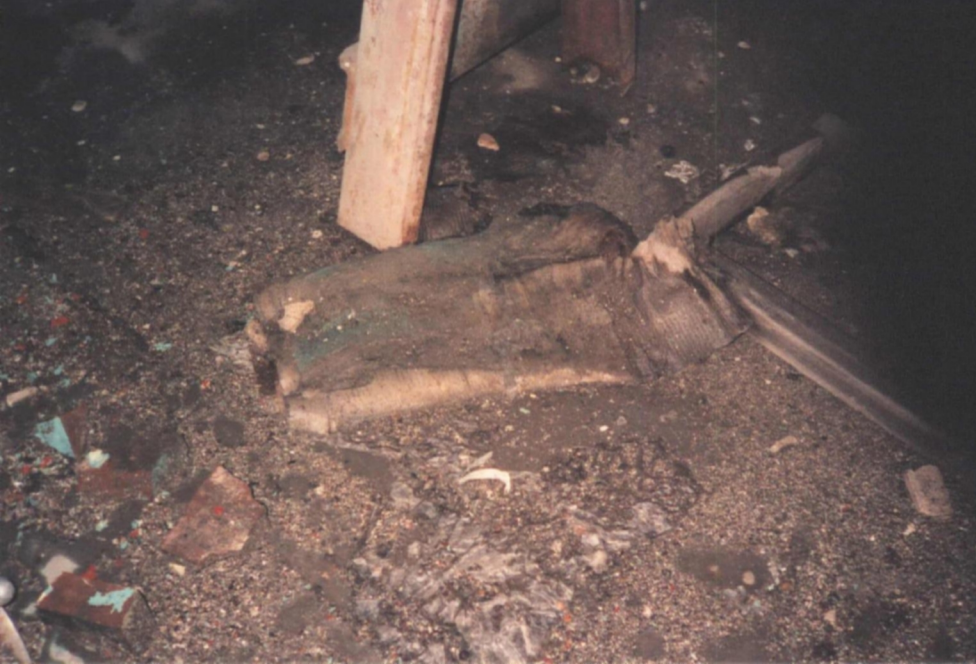
Photo #11

CAPTION: Southwest building.

Sample Site SBR19-003, obtained from the paper-type pipe insulation on floor underneath the deteriorating pipe insulation in Photo #10.

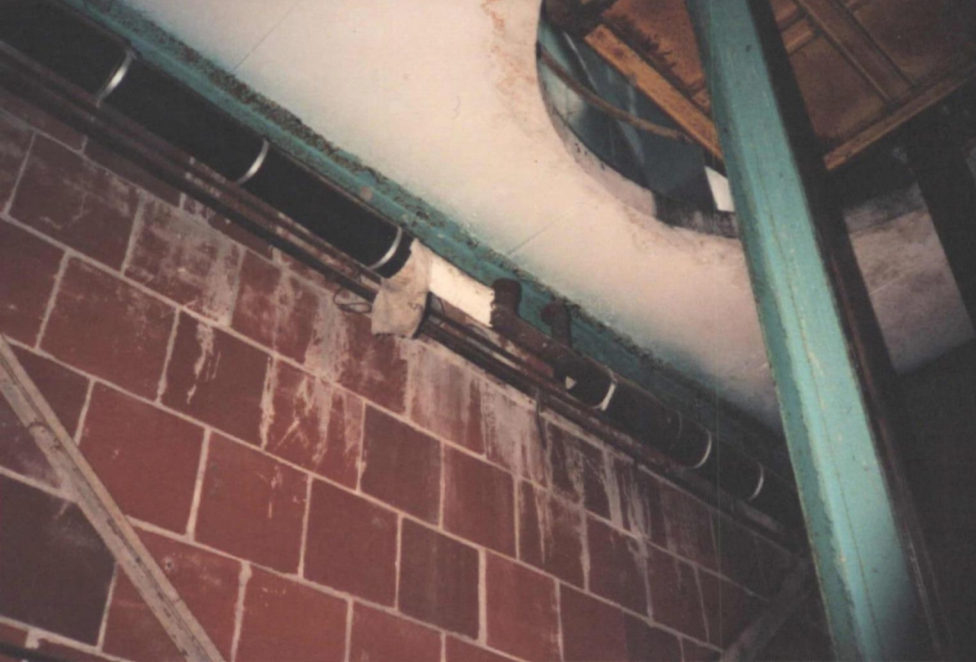
Photo #12

CAPTION: Southwest building.

Damaged pipe insulation.

Sample SBR19-004 obtained from insulation on  
floor under the pipe.

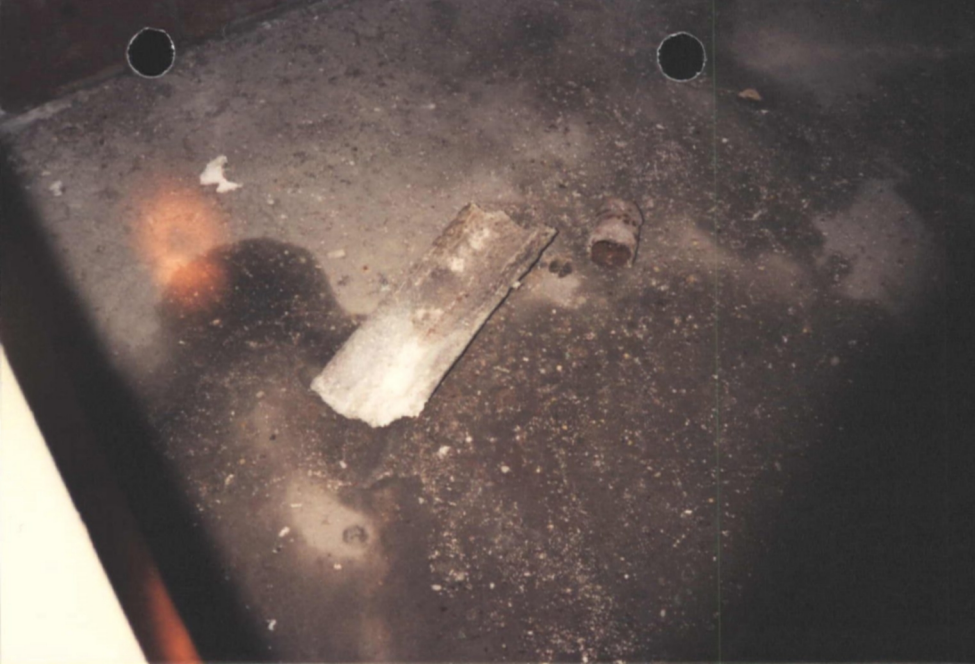
Photo #13

CAPTION: Southwest building.

Sample Site SBR19-004.

Block-type pipe insulation on floor.

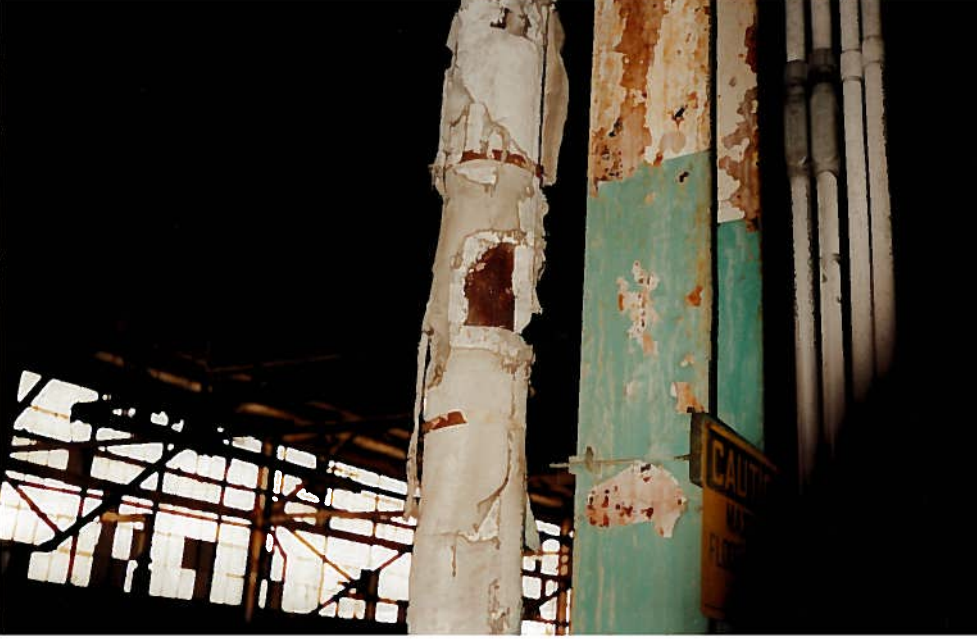
Photo #14

CAPTION: Southwest building, 2nd floor.  
Sample Site SBR19-005.  
Damaged block-type pipe insulation.

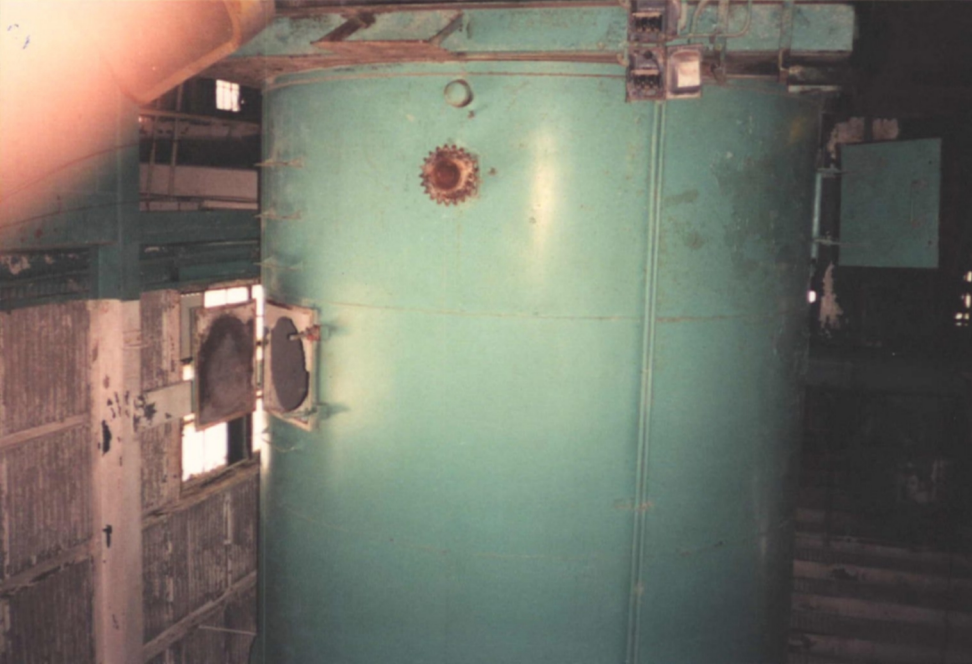
Photo #15

CAPTION: Southwest building, 2nd floor.

Large mixing vessel.

Sample Site SBR19-006 obtained from hatchway on  
right.

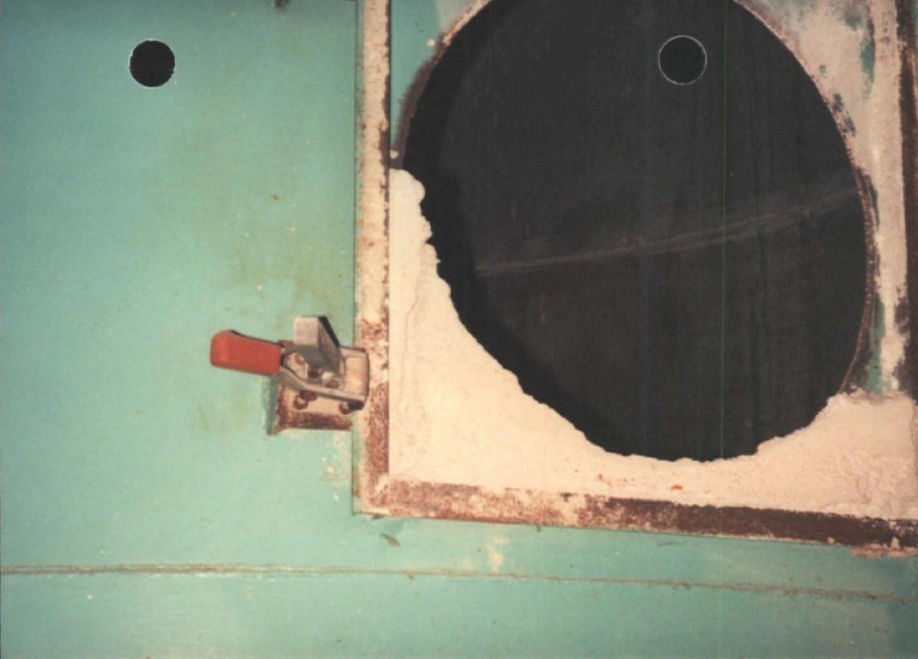
Photo #16

CAPTION: Southwest building.  
Sample Site SBR19-006.  
From mixing vessel hatchway.

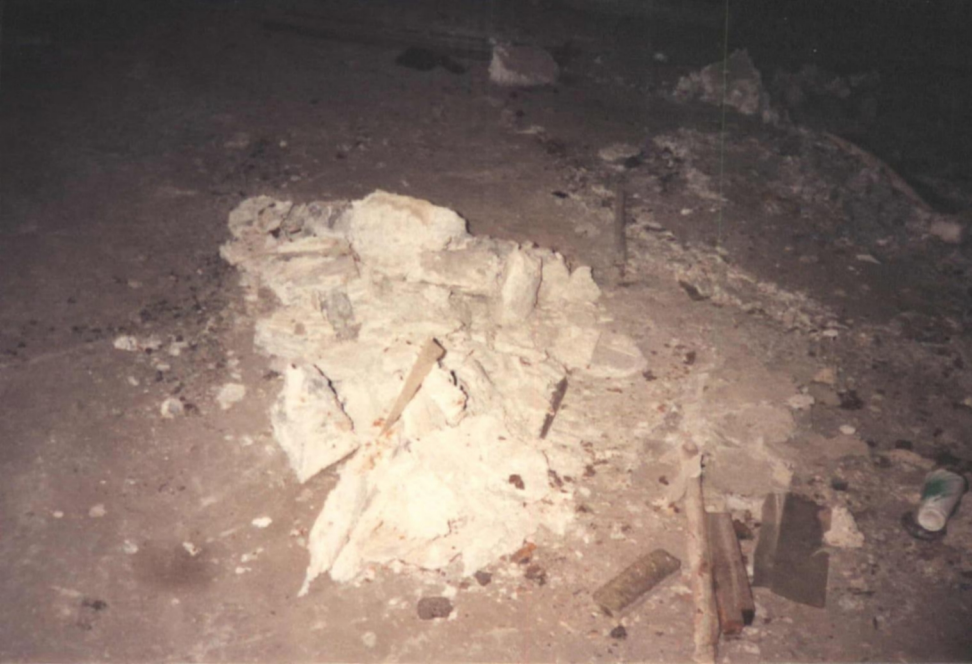
Photo #17

CAPTION: Northeast building, area A, 2nd floor.  
Sample Site SBR19-007.

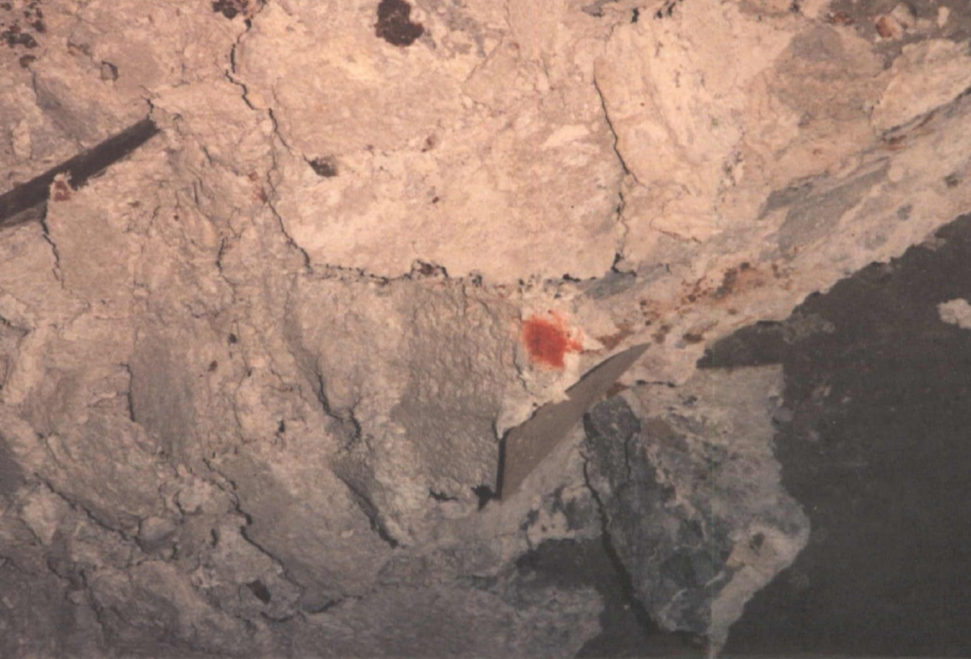
Photo #18

CAPTION: Northeast building, area A, 2nd floor.  
Sample Site SBR19-007.

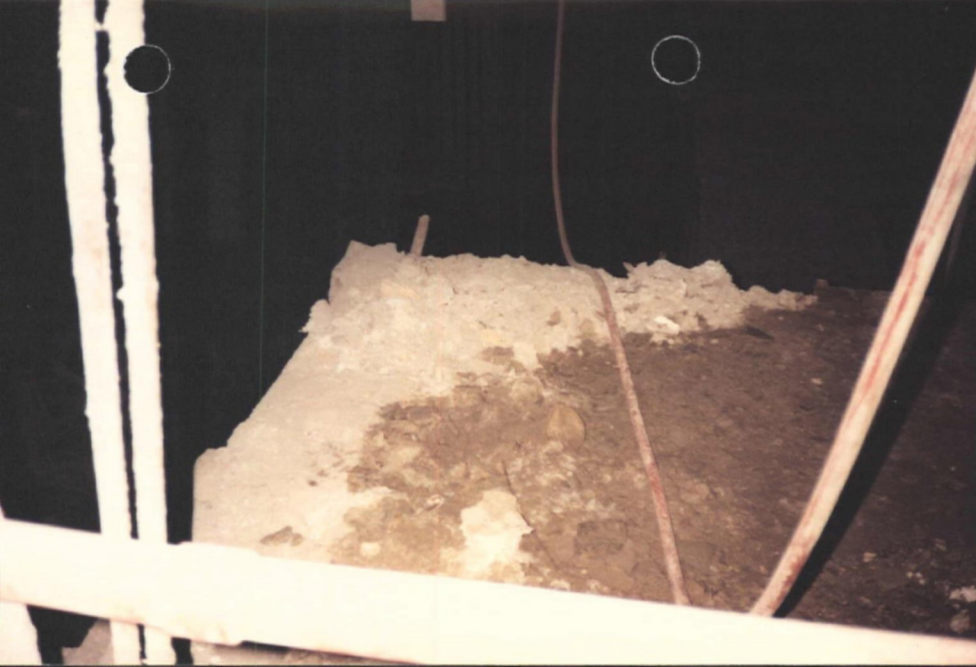
Photo #19

CAPTION: Northeast building, from area A to area B, 2nd floor.

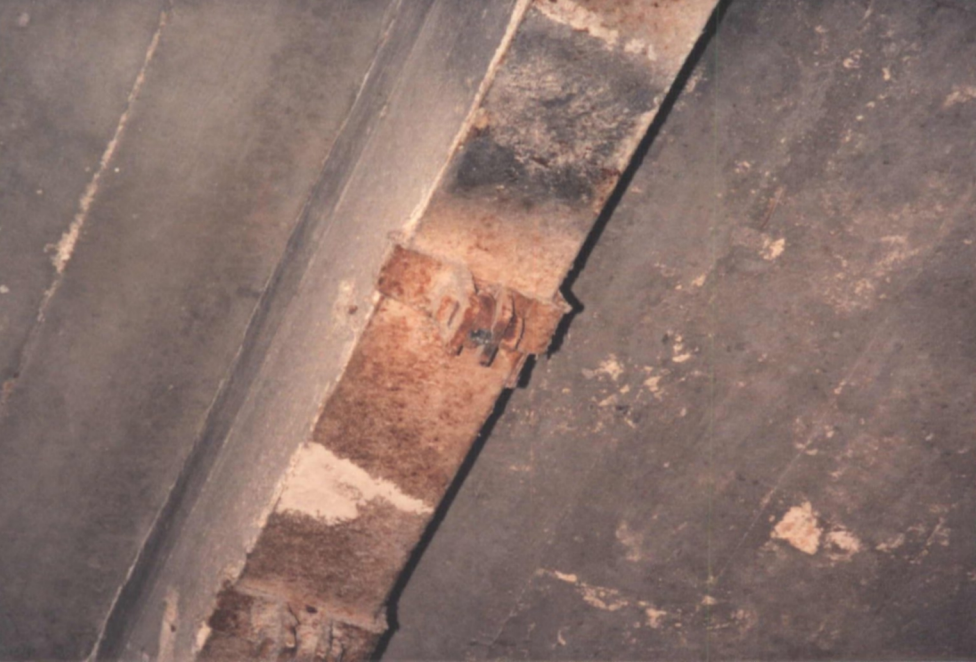
Photo #20

CAPTION: Northeast building, area A, 1st floor.  
Cut off hanger, suspended from ceiling.

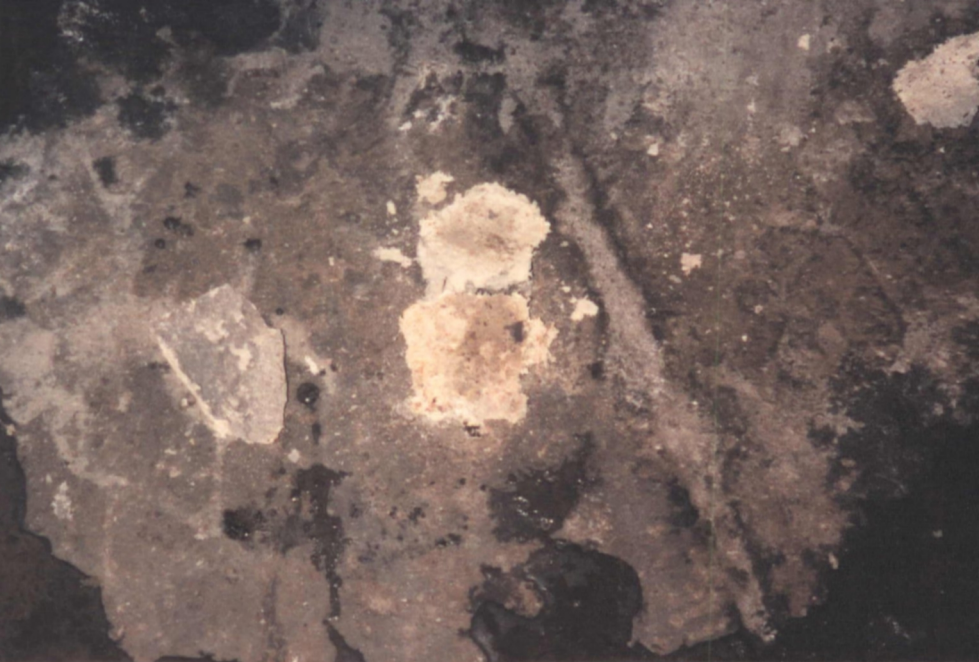
Photo #21

CAPTION: Northeast building, area A, 1st floor.  
Piece of suspect ACM located underneath cut  
hanger.

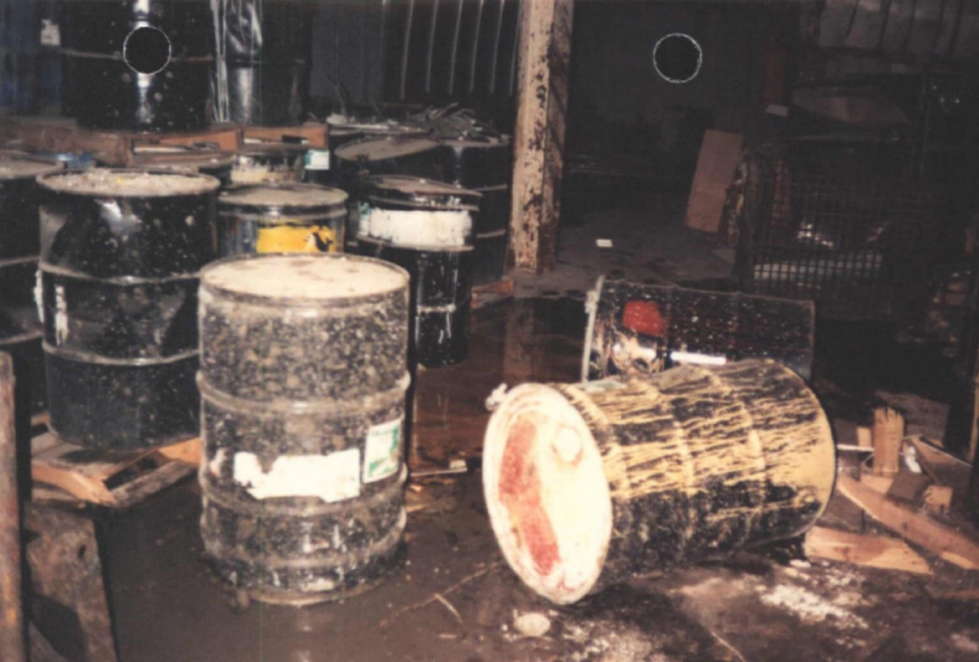
Photo #22

CAPTION: Northeast building, area A, 1st floor.  
Drums full of metal scrap.  
Oily spill under drums.

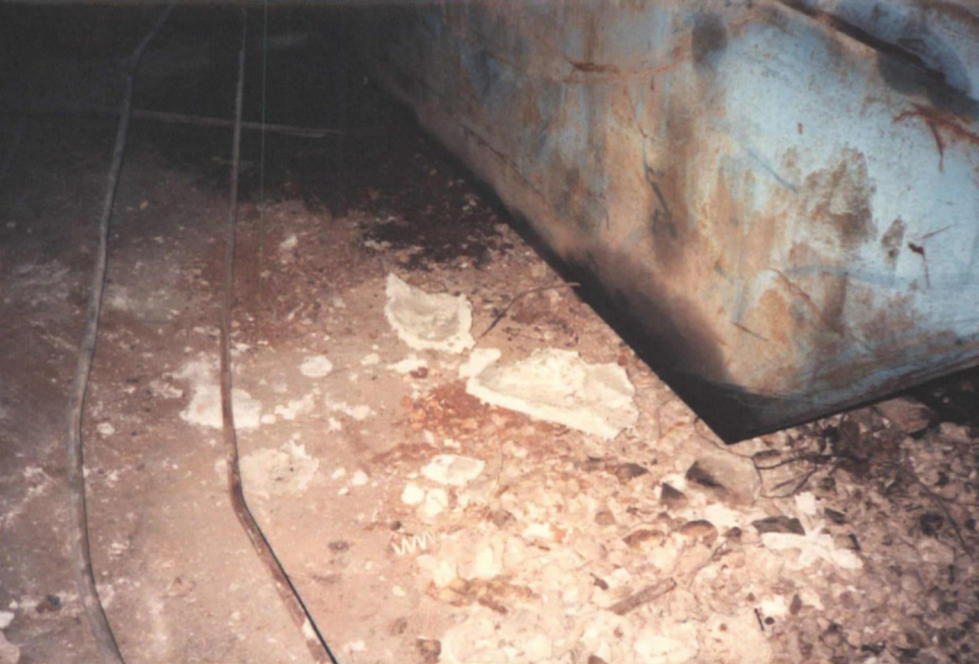
Photo #23

CAPTION: Northeast building, Area B.  
Suspect ACM on floor.

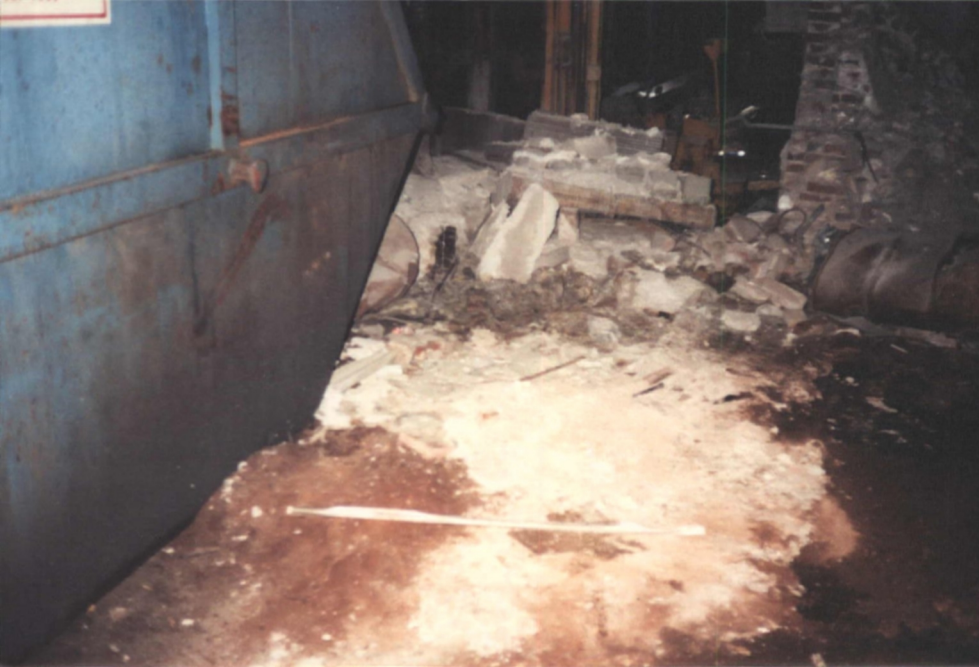
Photo #24

CAPTION: Northeast building, area B.

Sample Site SBR19-008. General area.

Suspect ACM on floor.

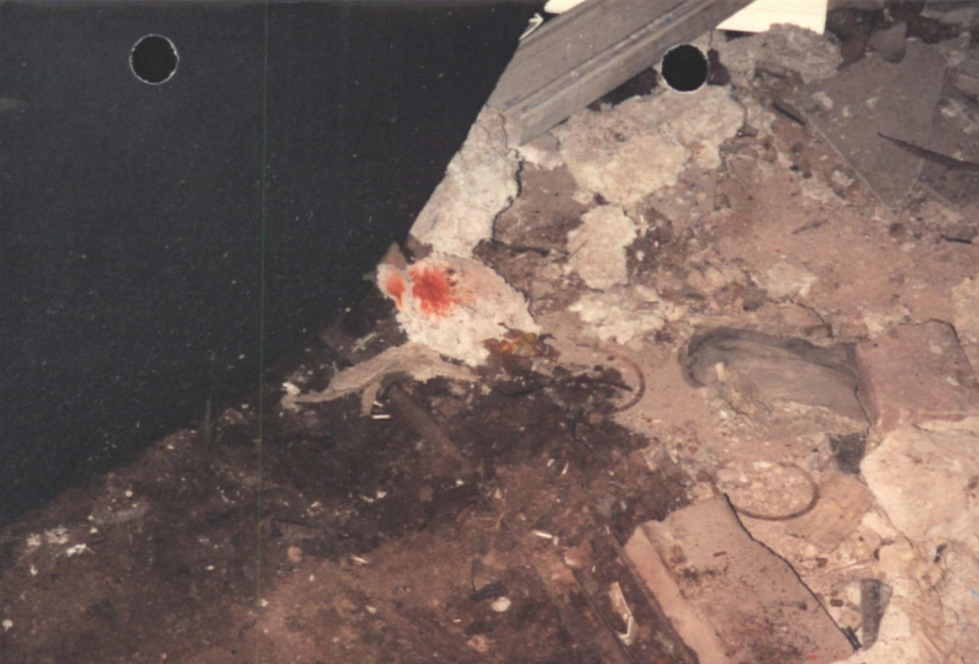
Photo #25

CAPTION: Northeast building, area B.  
Sample Site SBR19-008. Closeup.  
Suspect ACM on floor.

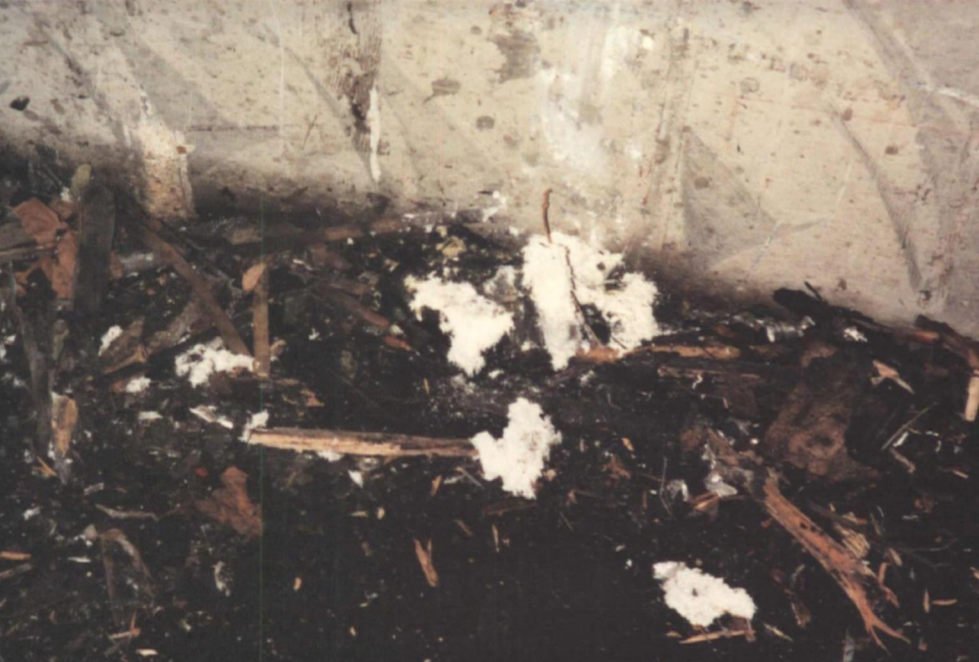
Photo #26

Suspect ACM laying on floor under cutoff pipe..

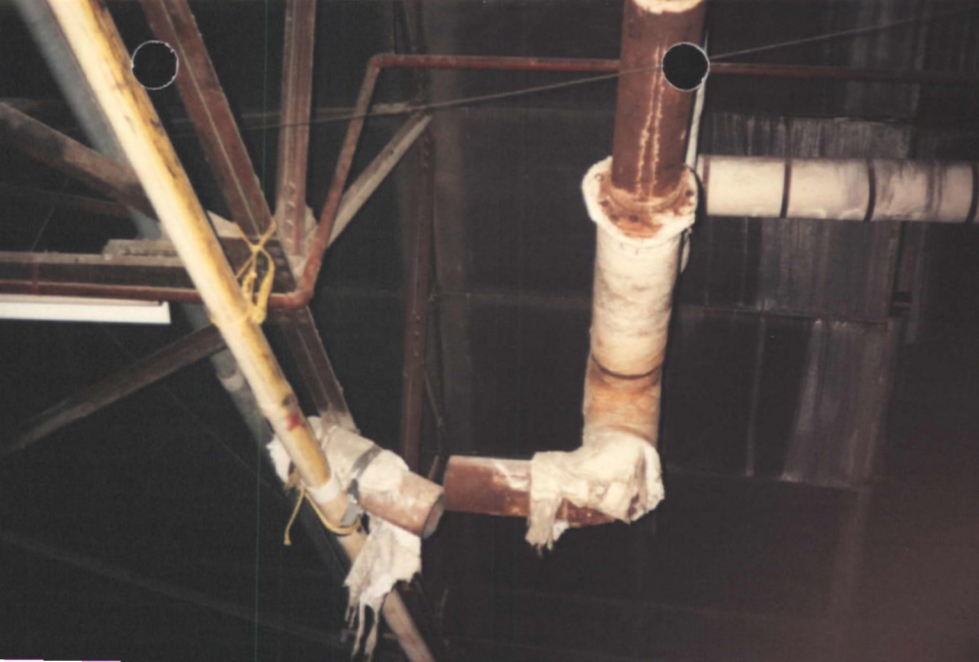
Photo #28

CAPTION: Northeast building, area C.  
Cutoff pipe with loose insulation.

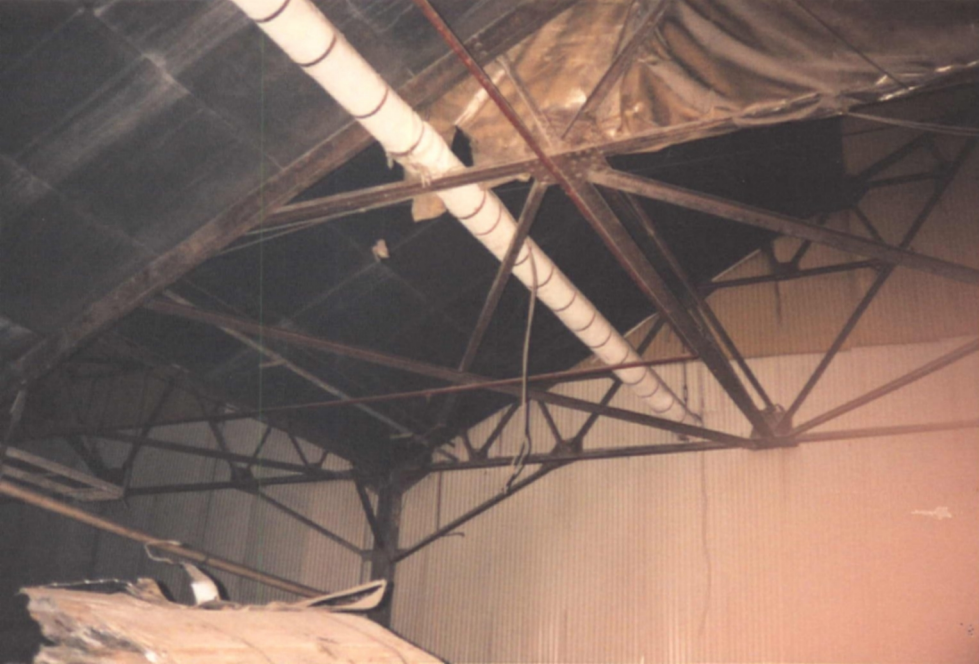
Photo #29

CAPTION: Northeast building, area C.  
Intact insulated pipe.  
Towards dividing wall with area B.
